THEATRE BUILDING COMPLEX

Gavilin College Campus

RENOVATION AND MODERNIZATION STUDY

December 3, 2021

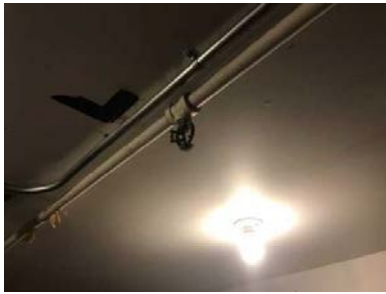
Fire Suppression System in Poor condition.

Existing Sprinkler Heads, by SF
Gilroy Campus Theater Throughout building

There are no theater seating handrails at any isles. Implement this and other suggested ADA changes as outlined in a separate report. - AssetCALC ID: 3444875

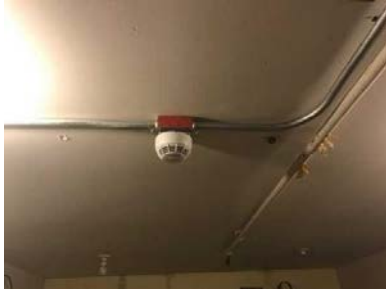
Fire Alarm System in Poor condition.

Full System Upgrade, Standard Addressable
Gilroy Campus Theater Theater

The fire alarm system is minimal for the occupancy. Emergency lighting throughout and stage exit signs are insufficient. - AssetCALC ID: 3444869

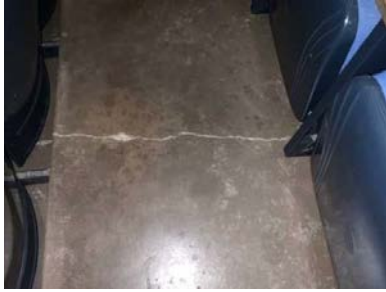
Structural Flooring in Poor condition.

Concrete
Gilroy Campus Theater Theater

Cracks are manifesting themselves from below the theater. The are migrating up and down the stepped concrete seating area. Cracks are visible at the theater's entrance and the exterior. Interior cracks are starting to open (separate) and chipping is taking place in areas. - AssetCALC ID: 3444877

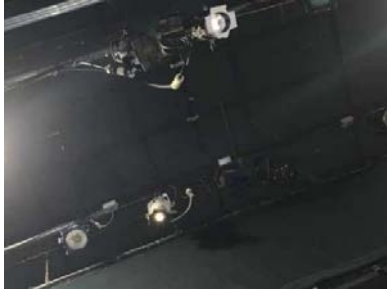
Structural Framing in Poor condition.

Stage Lighting Supports
Gilroy Campus Theater Theater

The stage lightning struts might be under engineered. They have been pieced together over the years with supports being added as needed. The actual anchors, ties, and supports were not likely engineered to support the stage lighting and related equipment. - AssetCALC ID: 3444872

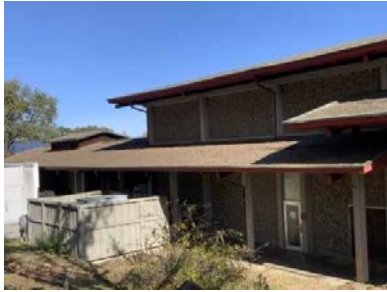
Roofing in Poor condition.

Built-Up
Gilroy Campus Theater Theater

The roof is leaking from several locations, both interior and exterior. Ponding is taking place in areas and it is unknown how extensive damage may be as a result of water migrations. - AssetCALC ID: 3444876

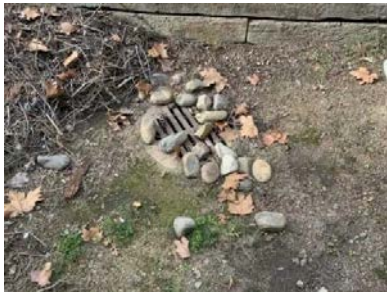
Plumbing System in Poor condition.

Rain Water Drainage, High Density
Gilroy Campus Theater Restrooms

When heavy rains occur, the drainage system is not large enough, or the existing drains are clogged, and the system can't handle the excess water. The result is water is flooding out of the floor drains in all the restrooms. Root intrusion is taking place in areas. - AssetCALC ID: 3444871

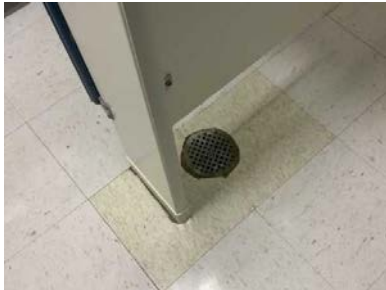
Plumbing System in Poor condition.

Supply & Sanitary, Low Density (excludes fixtures)
Gilroy Campus Theater Throughout building

When heavy rains occur, the drainage system is not large enough, or the existing drains are clogged, and the system can't handle the excess water. The result is water is flooding out of the floor drains in all the restrooms. - AssetCALC ID: 3352290

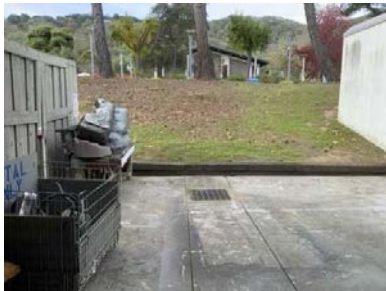
Site Earthwork in Failed condition.

Slopes & Contours, Reshaping/Regrading
Gilroy Campus Theater Building exterior

The site is sloped such that all the surface runoff for the campus runs towards the southwest side of the theater. This causes extensive flooding into the rooms on that side of the building including the main electrical room and into the theater itself. Clogged or insufficient site drains could also be contributing to the problem. - AssetCALC ID: 3444866

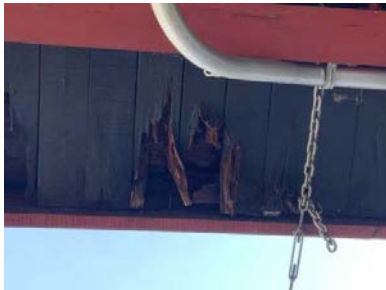
Soffit in Failed condition.

Wood
Gilroy Campus Theater Building exterior

The wood soffit is severely deteriorated and is getting worse over time. Initial attempts to patch and or repair have fallen short, once one hole is repaired, two or three more openings are created. The main issue is bats are using the soffit space as a home and thus have access to the interior of the building. - AssetCALC ID: 3444862

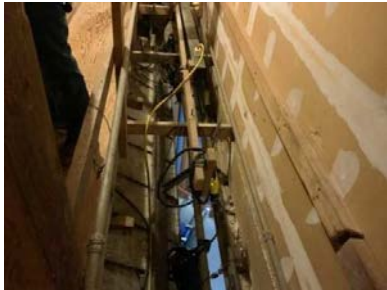
Interior Lighting System in Poor condition.

Full Upgrade, Medium Density & Standard Fixtures
Gilroy Campus Theater Theater

The house lighting is very dim, it appears only a partial upgrade to LED has taken place. There is no central isle lighting temporary rope lighting has been installed on the outside isles by maintenance. The lighting controls are not centralized. The stage lights are old, they are not connected to the house system, and arcing is taking place. - AssetCALC ID: 3444868

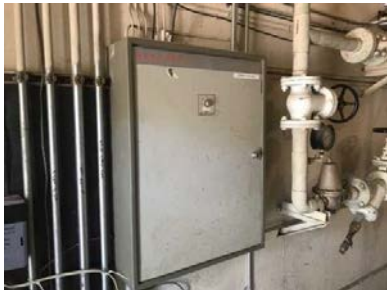
BAS/HVAC Controls in Poor condition.

Retrocommissioning of System
Gilroy Campus Theater Building Interior

The chiller and boiler only supplies two of the three air handlers located on the site (one in each building). It is unclear why the third is not operating properly. Even then, the two they are being supplied, are producing in a manner that is unreliable. The units themselves appear to be in good shape and new in installation. Areas of the facility are inadequately heated, cooled or ventilated, Poorly insulated areas. - AssetCALC ID: 3444874

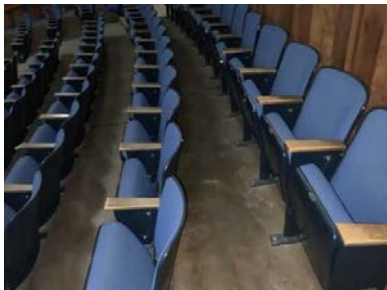
Fixed Seating in Poor condition.

Auditorium/Theater, Metal Cushioned Standard
Gilroy Campus Theater Theater

Seat cushions are detaching from their metal housing. Springs are starting to detach and poke through the seat material. The metal seating is worn so that seats don't always automatically fold-up, nor do some of them support properly by folding down past the initial breaking point. - AssetCALC ID: 3444865

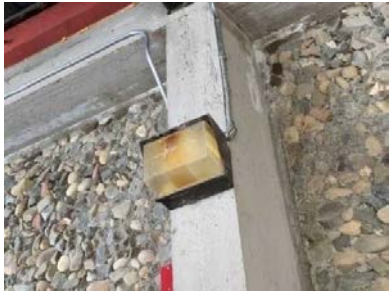
Fixture w/ Lamp and Housing in Poor condition.

Any Type, w/ LED Replacement
Gilroy Campus Theater Building Exterior & Interior

There is not enough exterior lighting and the housing (light covers) of existing fixtures, interior and exterior, are stained and reduce the quantity of light being emitted by the fixture even if the bulb is new. While the light covers are being replaced, all bulbs/fixtures should be upgraded to LED's. Additional lighting may be required on the exterior after a full replacement of the light covers takes place. - AssetCALC ID: 3444867

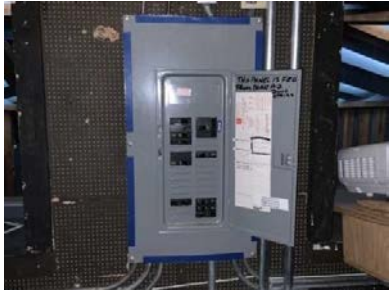
Electrical System in Poor condition.

Full System Renovation/Upgrade, Medium Density/Complexity
Gilroy Campus Theater Throughout building
