# Gavilan College

## Canopy Assessment

April 28, 2021  
P2S Project #21-0126

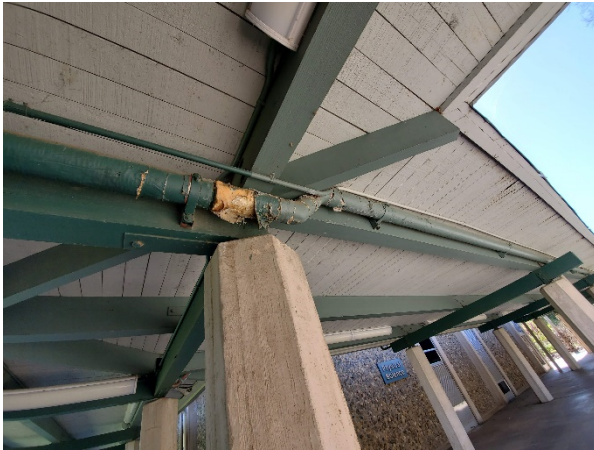
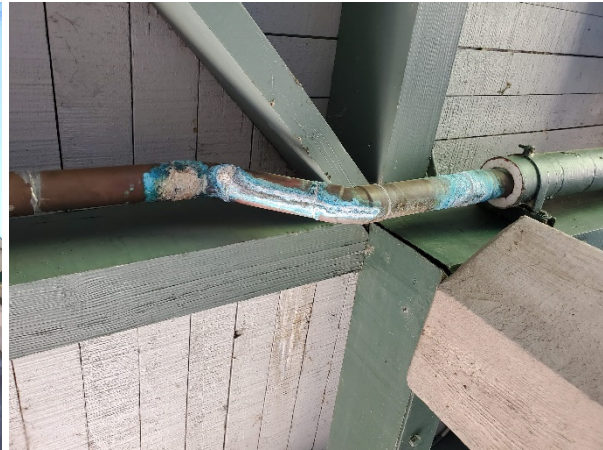
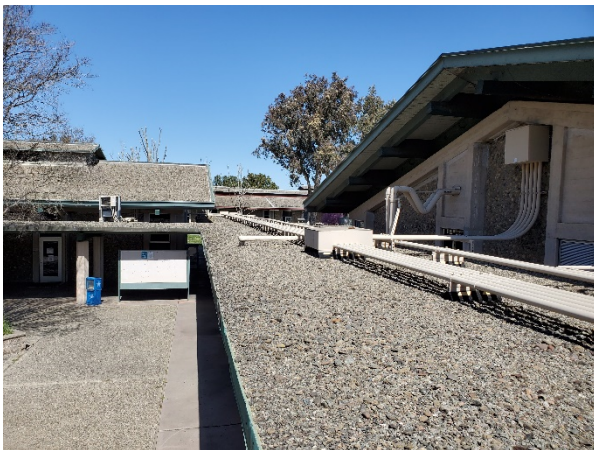
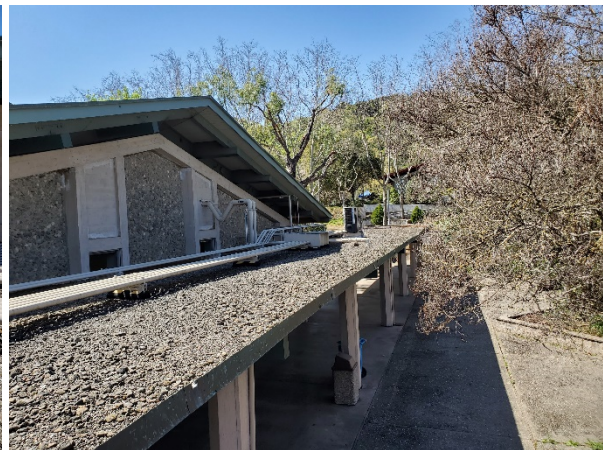
The Campus does not have a central heating plant; Instead, buildings are grouped together, and are connected to a centrally located boiler. The cooling demand for each building is being addressed at the building level for all buildings. During our survey our team documented two boilers serving the Math building. The hot water generated by these boilers then is being pumped to the Physical Sciences and Life Sciences buildings to meet their heating demands. The piping between the three buildings is routed within canopy number 1. The piping location with respect to the canopy varies, but generally it runs above the canopy roof near the connections to the building and under the canopy roof (strapped to the beams) as it travels between the buildings. The above-mentioned heating hot water lines are generally in poor condition. In multiple locations along the piping the insulation is missing, in some locations there are signs of leakage. Being that the existing insulations on the piping below the canopy roof do not have any protection shielding, the insulation canvas has deteriorated through time as it has been exposed to environmental stresses.

In order to replace the existing canopies, in any extent, shape, or form, the current piping would have to be removed first. Nonetheless, the existing condition of the heating hot water distribution piping is such that by itself, it warrants a replacement of the system. We recommend that the existing heating hot water piping system be replaced with a new piping system adequately insulated and properly installed. These upgrades will result in loss of heating system for the three aforementioned buildings. We recommend that the replacement project to commence during warm seasons or alternative means of heating may need to be provided.

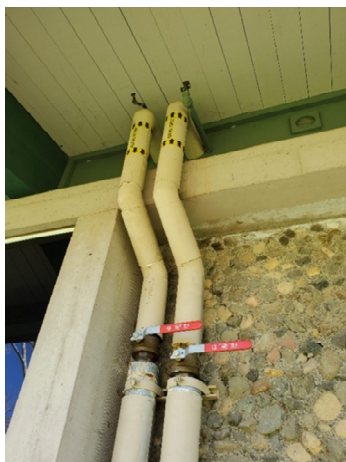
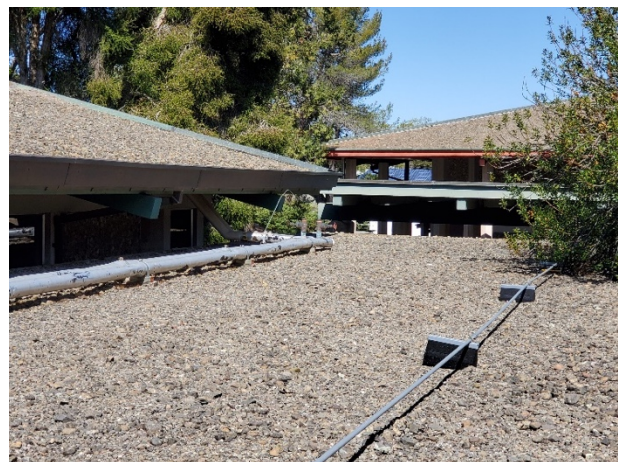
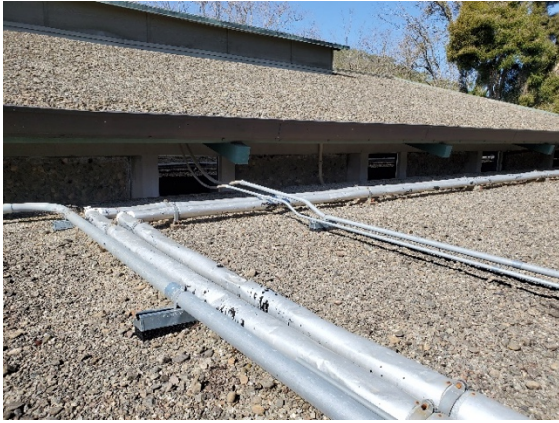
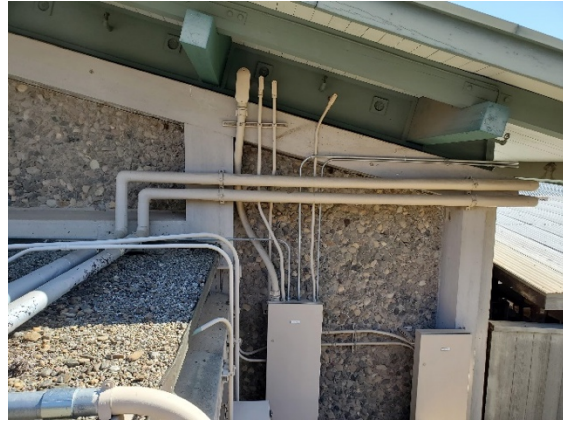
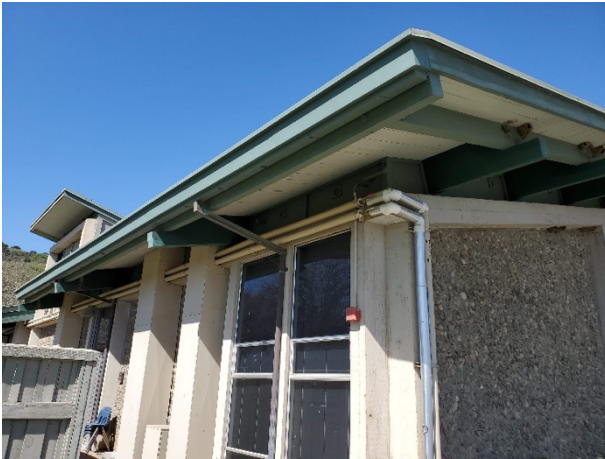
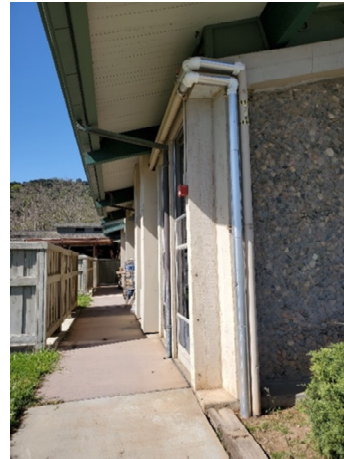
Similar to canopy number 1, canopy number 2 houses some heating hot water piping. The existing heating hot water piping serves Humanities, Arts and Music building. The boilers and pumps feeding this system appear to be located in the Business building across the campus's main walking path, on the east side of Humanities building. Heating hot water is pumped from the Business building to underground piping that run between that building and Humanities. The supply and return pipes then rise on the east side of Humanities building (See FIG2-1 below) and travel through this building to serve this building. These pipes then continue through the building and exit on the west side, above canopy roof number 2 (See FIG2-2). From that point the heating hot water supply and return pipes travel south to wrap around the south and west sides of the Arts building (See FIG 2-3 and FIG 2-4). These pipes feed the Arts building from the south side (See FIG 2-5), pipes travel east along building, then the supply and return pipes drop underground, at east end, and travel underground to Music building (See FIG 2-6).

During our survey multiple locations where documented to have damage or missing insulation. The pipe supports on top of the canopy appeared to be adequate.

If the College decides to replace canopy number 2, the portion of the existing heating hot water supply and return piping that lays above the roof of the canopy shall be replaced. We recommend that repairs be completed to piping insulation on portion even beyond canopy footprint.

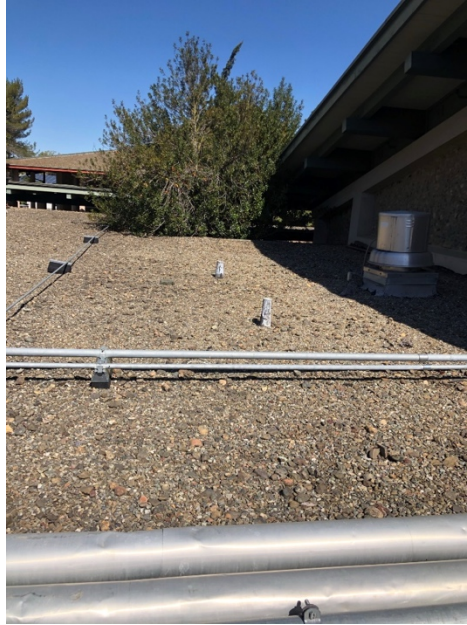
**FIG 2-7**

It appears that canopy #2 and the roof of the Arts building restrooms is part of one roofing system. During the survey an existing exhaust fan was documented to be above the restroom roofing. If the restroom roof needs to be replaced as part of the canopy replacement, the existing exhaust fan serving the restrooms shall be removed and reinstalled after the new roof is in place. The existing bathrooms will not be occupiable during this period.

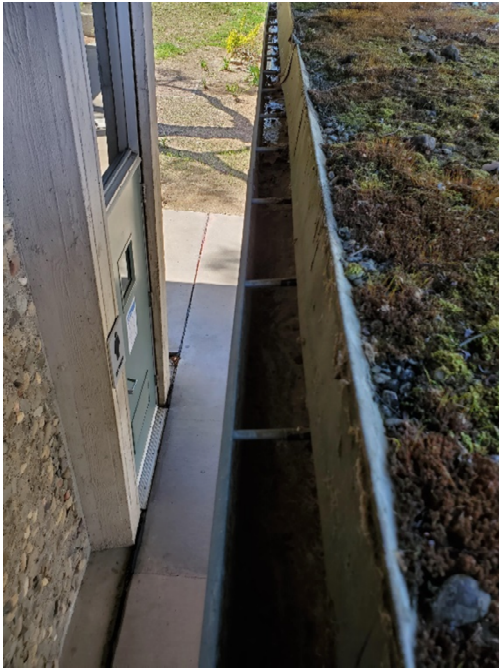
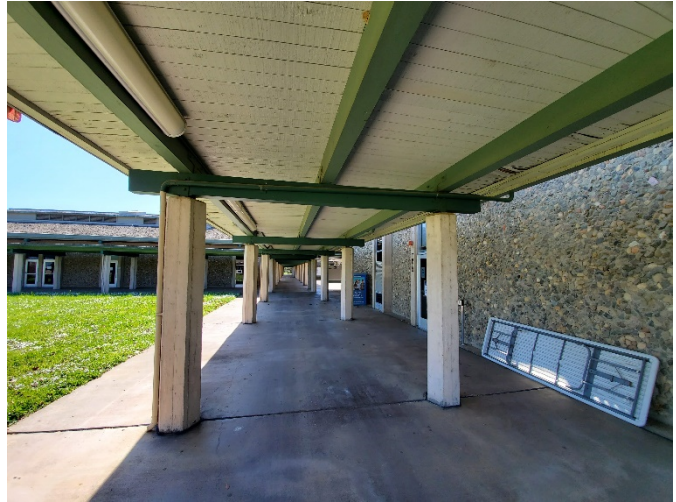
Storm drainage system for canopy number 1 consists of a gutters system with downspouts located in various locations throughout the canopy. The gutter system appeared to be in working condition in some areas, but in other locations it needed to be cleaned out. For the gutters at the Life Sciences building, the gutter system has a lip that prevents stormwater from getting into the gutter. This condition has caused a small amount of water to stagnate on the roof and resulted in vegetation growing near the roof's edge.

Downspouts on canopy number 1 consist of galvanized pipes running from gutters down alongside the columns and discharge to the ground at the foot level. These pipes are supported mainly by the canopy's structure using pipe clamps. Overall, the gutter and downspout systems provided for this canopy are undersized for the area of the roof they cover. We recommend that when the canopies are being replaced, a new adequately sized drainage system be provided for the new canopies.

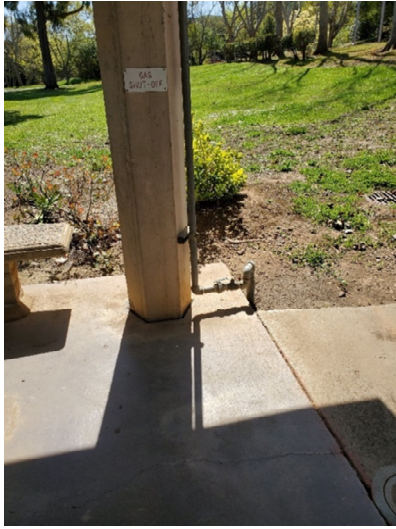
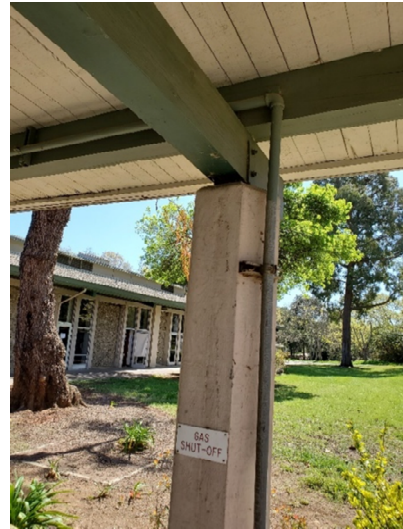
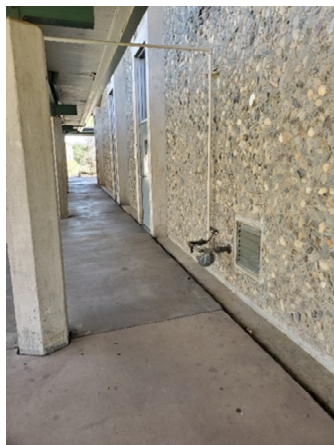
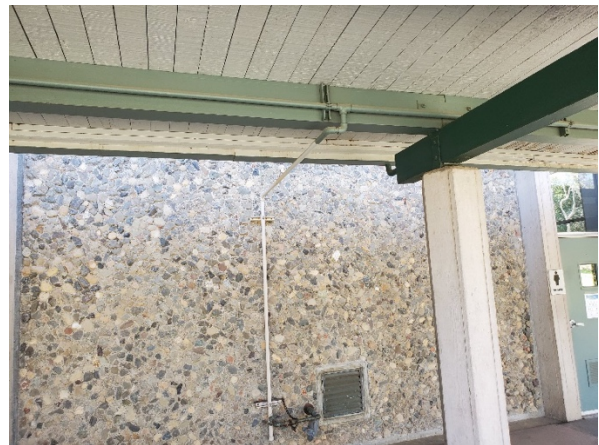
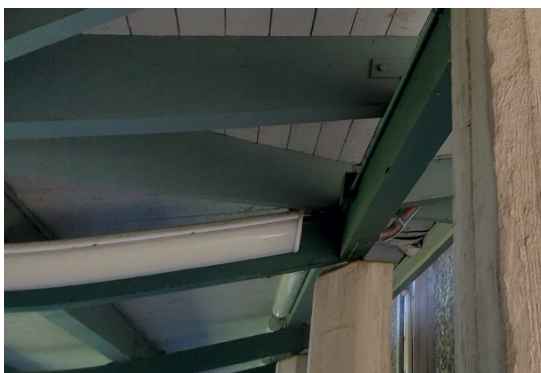
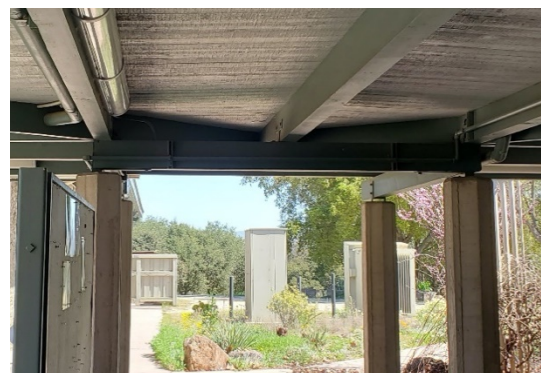
There is a 2-inch natural gas distribution piping that runs from north to south alongside the Life Sciences building to feed both the Life Sciences building and the Physical Sciences building. This pipe is attached to the columns supporting the canopy.

A branch of this gas pipe runs along the east wall of the Life Sciences building to connect to the gas pressure regulator in that location. The gas pipe then travels towards the south to serve the Physical Sciences building.

Near the Physical Sciences building, the gas pipe turns east and runs under the structure. In this location, the gas piping material changes from steel to copper. This can cause corrosion in the gas piping and result in gas leaks and fire hazards. We recommend this issue be immediately addressed by providing a dielectric union on the piping to protect piping from any galvanic reaction.

Based on the extent of the canopy replacement project, the existing gas piping may need to be removed to accommodate the structural upgrades. The gas piping is currently attached to the beams holding the roof structure. If the intent is to replace the entire roof framing, the gas piping shall be removed, and new piping shall be provided. This will cause interruption to the gas service at Life Sciences and Physical Sciences buildings.

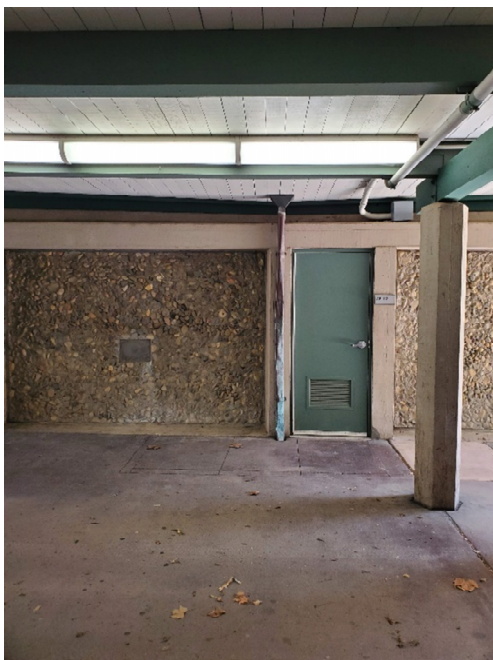
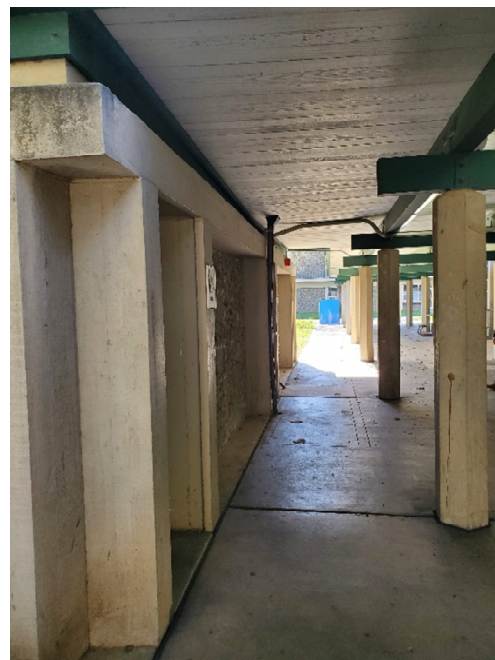
Canopy number 2 only contains one roof drain located near the restrooms at the exterior of the Arts building. The existing roof drain is 3 inches in size. Based on our initial observations, it appears that this roof drain only covers the roof area above the restrooms and the portion of the canopy in front of the restrooms. Based on the observations above, the size of the roof drain is considered to be adequate; however, the downspout was observed to be damaged, and it needs to be repaired.

The rest of the canopy does not have any means of collecting stormwater from the roof. The storm will sheet flow to one edge and drip from the edge of the roof.

Based on the observations reported above, If the canopies are to be replaced, the existing roof drain would have to be replaced to go with the new roofing system. We recommend that the existing rain leader (that is currently damaged) be replaced with the new roof drain.

We also recommend additional means of roof drainage be provided to convey stormwater from the roof down to the walking surface.

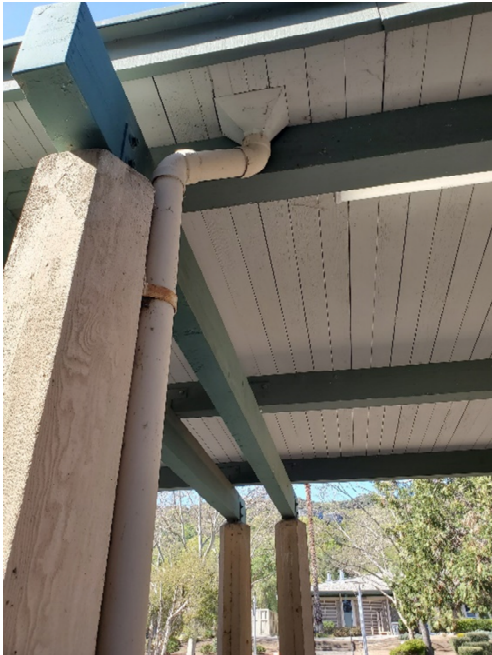
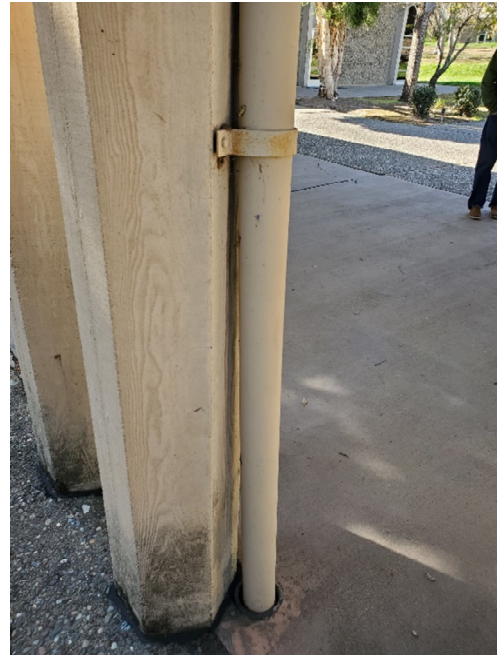
Canopy number 3 extends from the south side of the Theater building and connects to canopy number 2. This canopy was observed to be at least 10 inches higher than the adjacent canopy #2. Canopy #3 has two separate drainage points. Both drains are 3-inches in size, and they connect to two separate 3 inch

cast iron rain leaders. Each rain leader runs next to an adjacent column and discharges into a dedicated receptor in the pavement.

One of the roof drains was documented to be missing the gravel stopping mesh.

Based on our observation, we recommend that in case the roof of this canopy is being replaced, a new roof drain be provided that will be compatible with the roof structure. The new roof drain shall have a gravel stop feature to prevent any gravel from getting into the storm drainage system.

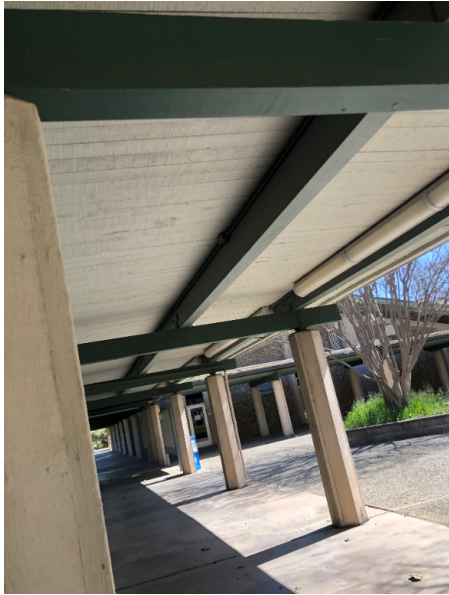
FIG 1-1

Multiple 4' linear wraparound fixtures are located between canopy pillars.

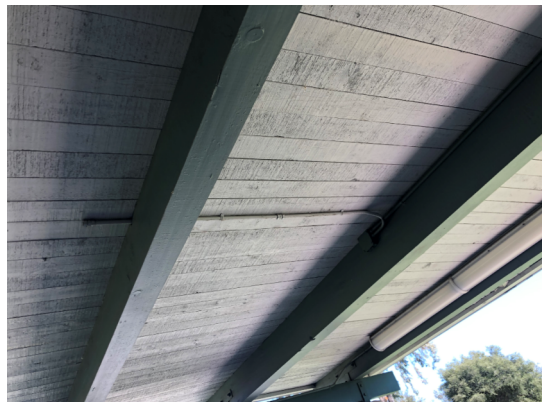
FIG 1-2

Conduit and boxes are located below canopy roofing. There is no indication conduits contain any live branch circuits. Boxes have been capped, appears conductors and raceway have been abandoned in place.

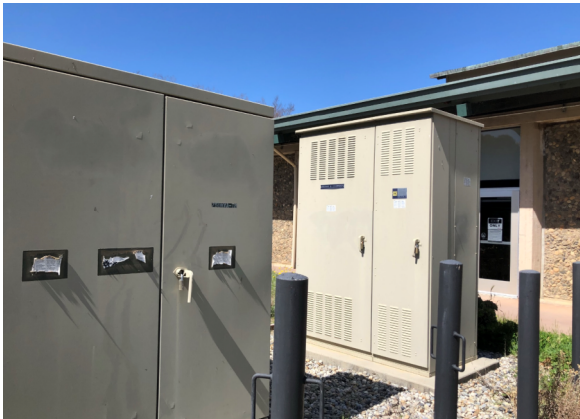
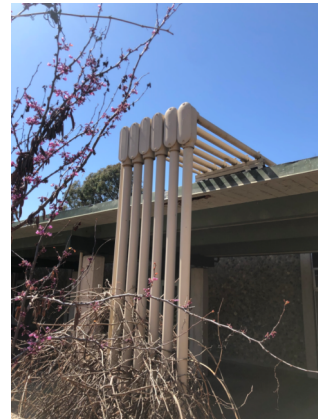
An electrical 480V service, South East of Canopy#1, feeds Life Sciences, Physical Sciences and Math building. (6)3"C and (1)1"C are stubbed up and routed up and surface to canopy roof.

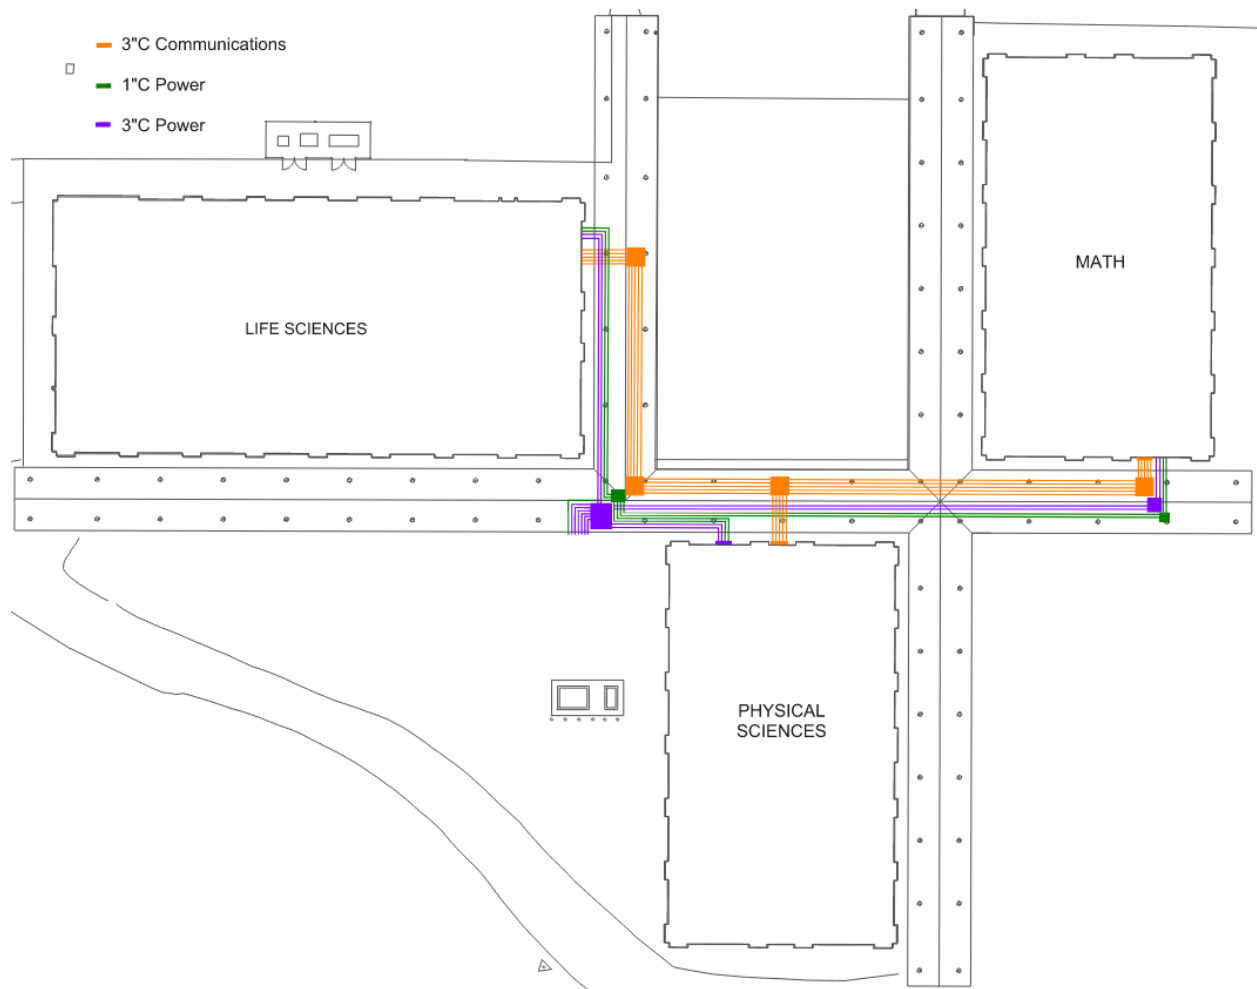
**FIG 1-7**

(2)3"C and (2)1"C are distributed to each building along the canopy roof. There are three additional 3'x3' boxes on roof, with (5) 3"C for the telecom distribution system.

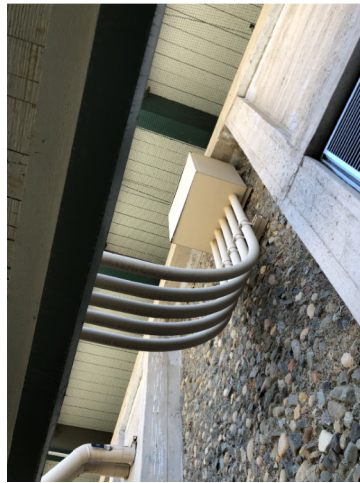
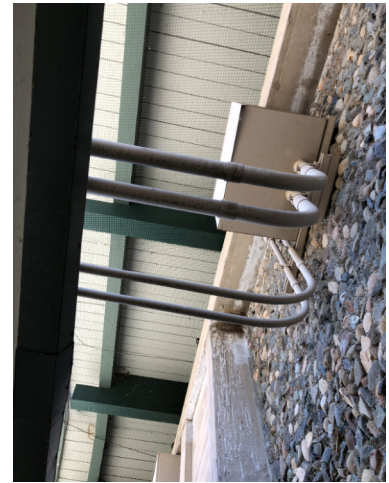
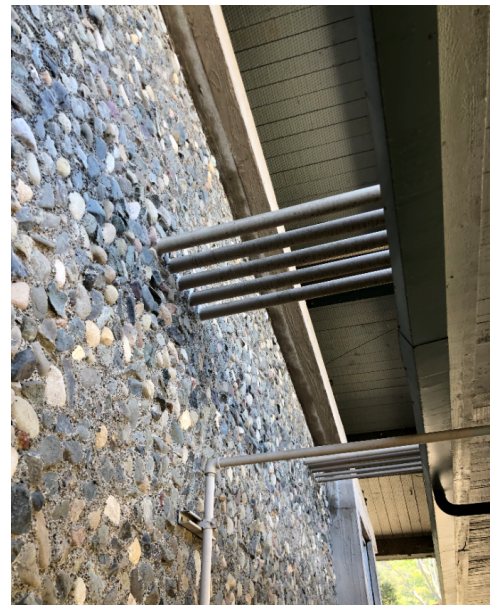
Existing concrete will be removed in the courtyard to allow new vaults and conduit for the power and technology services. Where the buildings currently connect from the canopy to the building (see figures 1-7B, 1-7C, 1-8B for examples of crossings) the new services would route surface from below grade, surface up the wall to the existing connection point. A service outage for both power and technology is required to allow the cutover.

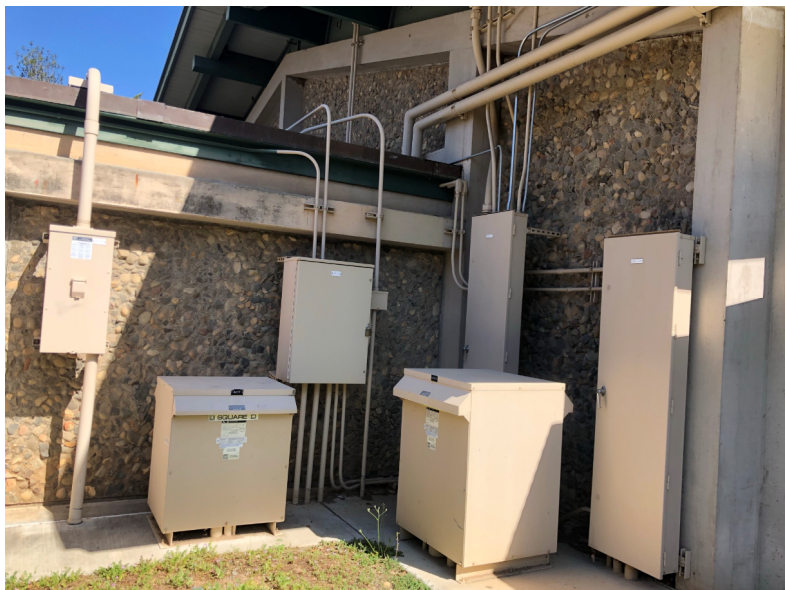
**FIG 2-1**

480V service appears to feed two 208/120V system, located South of Arts Building.

Canopy #2 appears to be a continuous structure, and part of the Arts' restroom roof.

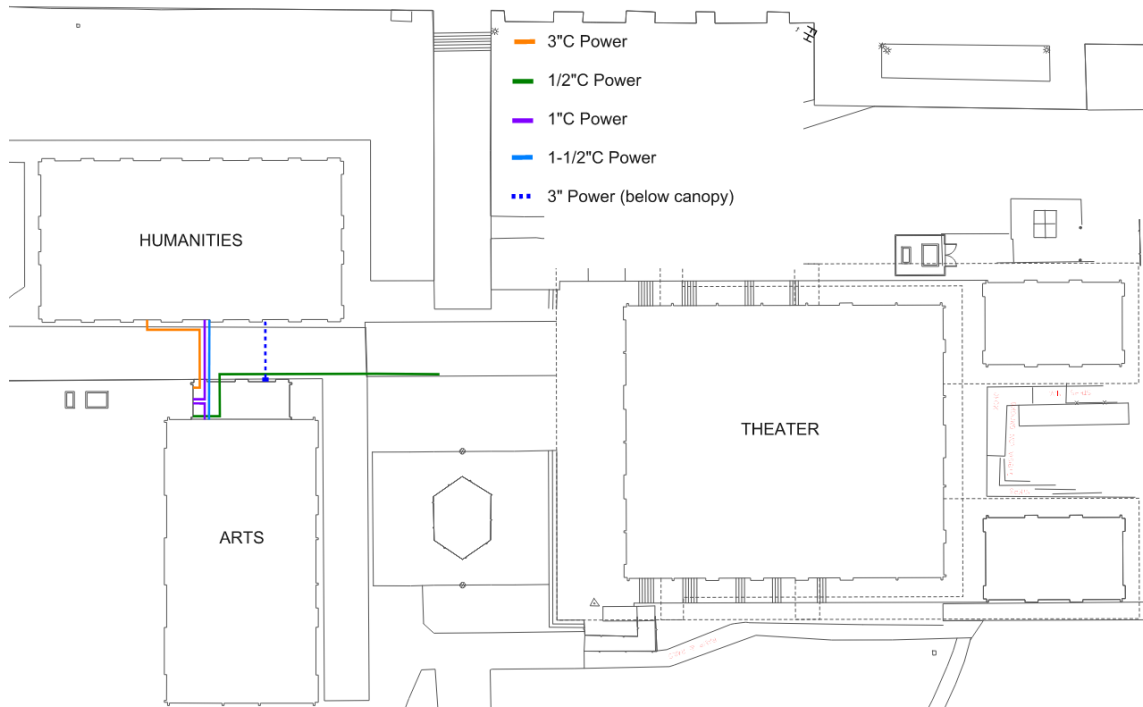
**FIG 2-2**

There are (5) conduits routed above the canopy/ restroom roofing.

An additional conduit stubs out of restroom building and is routed below the canopy.

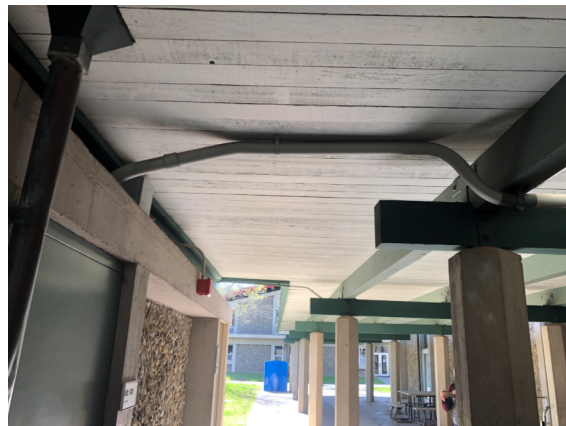
**FIG 2-5B**

There is a 3" conduit that currently routes under the canopy (Fig 2-5B). Our recommendation is to protect this conduit in place and build the canopy over this.

- c. Provide temporary service and supports for branch circuits routed above canopy and restroom roof.
  - d. Provide temporary supports for (3") conduit routed below canopy. This should be protected in place during canopy repairs and shall be permanently fixed to new structure.

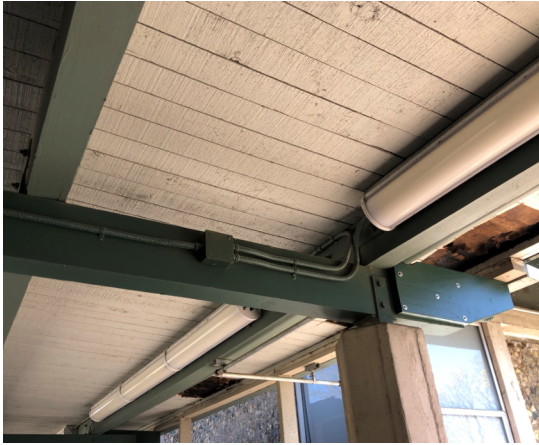
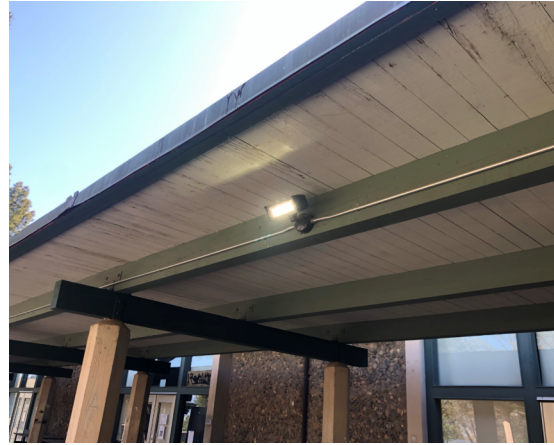
Multiple 4' linear wraparound fixtures are located between canopy pillars.

1. 14 sections – (3) 4' fixtures along outer end of canopy
2. 2 sections – (2) 4' fixtures at center pillars, where canopy branches out
3. 1 section – (1) 4' fixtures South of center pillars

Two flood lights, facing Theater/Arts quad, are located North of Arts building.

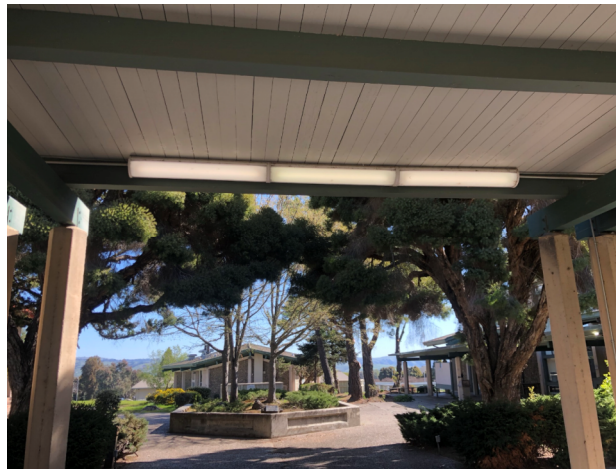
**FIG 3-1**

Multiple 4' linear wraparound fixtures are located between canopy pillars.

1. 3 sections – (3) 4' fixtures along outer end of canopy

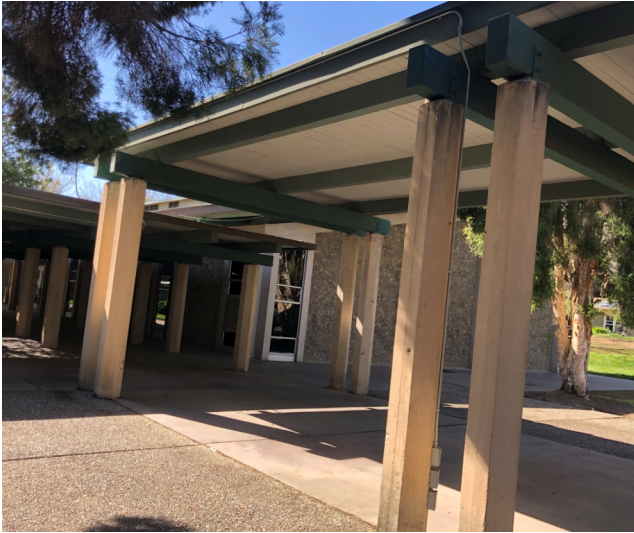
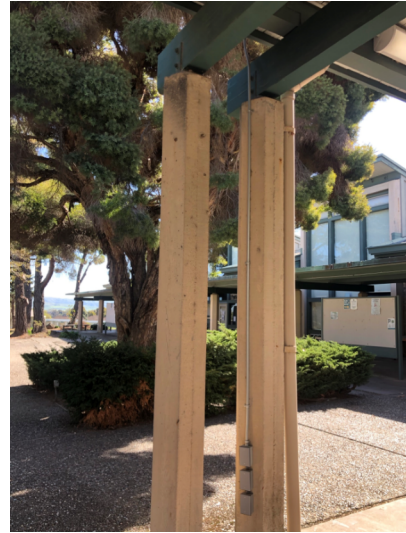
(1)1/2" C, routed above restroom roof/canopy #2, feeds into (3) boxes on Canopy #3 column. Boxes have been capped, appears conductors and raceway have been abandoned in place.
