# Gavilan College

## Canopy Assessment

April 28, 2021  
P2S Project #21-0126

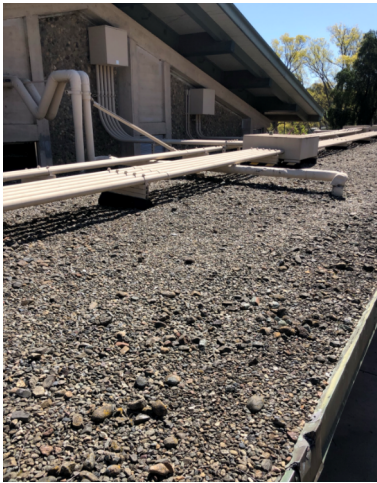
**FIG 1-7A**

(2)3"C and (2)1"C are distributed to each building along the canopy roof. There are three additional 3'x3' boxes on roof, with (5) 3"C for the telecom distribution system.
